ACTION MEMORANDUM - Request for Approval and Funding for a SUBJECT:

Time-Critical Removal Action at the Multi-Service Site, Dayton,

Montgomery County, Ohio (Site ID # C508)

FIGURE A-4 PHOTOGRAPHIC DOCUMENTATION

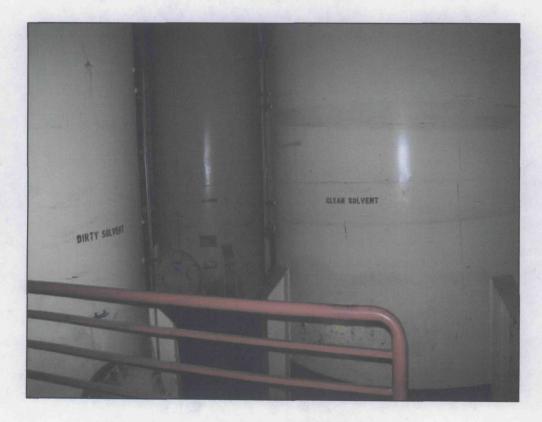
Many of the drums, totes and containers could not be identified by labels. However, several drums, totes and containers were labeled as containing sodium hydroxide, stoddard solvent, citric acid, and flammable liquid. Several were noted to be leaking and most were observed to be in poor condition. Approximately two inches of solvent/water mixture was noted on the tank room floor indicating that waste solvent tanks were leaking.

Photo 2: Solvent tanks in the Tank Room

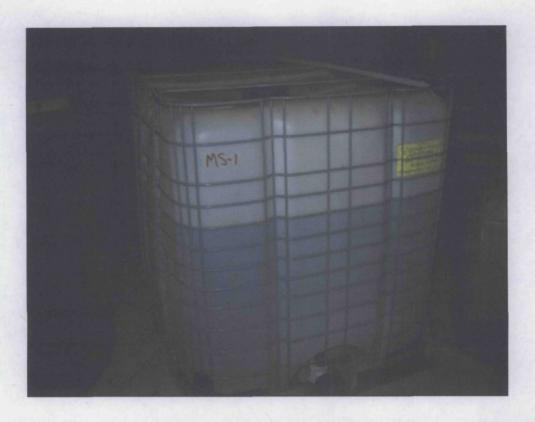
Analytical results from samples MS-1, MS-2, MS-4, MS-7 and MS-12 documented liquid having flash points less than or equal to 140°F, which verifies the characteristic of a hazardous waste for ignitability (D001), according to the Resource Conservation and Recovery Act (RCRA). In addition, on April 22, 2010, Ohio EPA documented the liquid contents in Equalization Tank #2 and the wastewater treatment sump pit having a flash point of 137°F and 131°F, respectively, which verifies the characteristic of a hazardous waste for ignitability (D001).

Photo 3: Sample Location MS-1 --- 250-gallon tote containing flammable (100°F flash point) "Stoddard Solvent" liquid

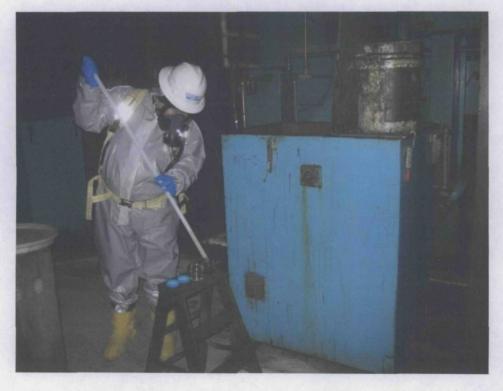
Photo 4: Sample Location MS-2 --- Solvent recovery container adjacent to dry cleaning line having a flash point of 110°F

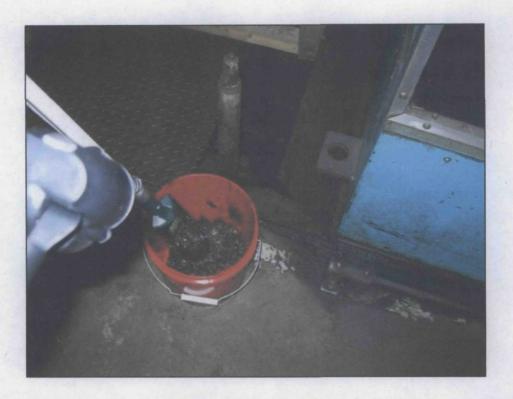
During the assessment, eight tanks, two pits and approximately 50 drums, totes and small containers (5-gallons or less) were documented on Site. Numerous dry cleaning machines (with solvent recovery tanks) and distillation units were also observed to be mounted over a containment trench in the facility floor. The contents within the trench appeared to be black sludge.

Photo 5: Sludge and debris observed in the trenches located underneath the dry cleaning machines.

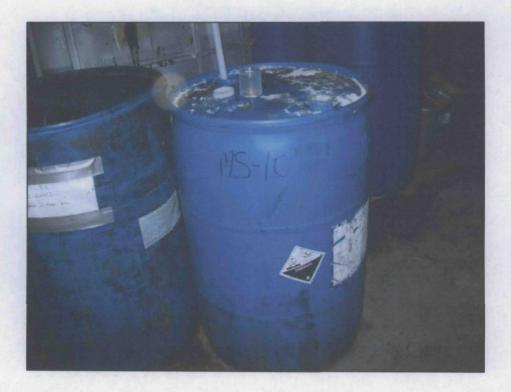
Analytical results from drum sample MS-10 documented liquid having a pH of 13 standard units. Analytical results from bag sample MS-11 documented a solid having a pH of 1.6 standard units. Analytical results from drum sample MS-10 indicates a pH level greater than 12.5 standard units, and analytical results from solid sample MS-11 indicates a pH level less than 2.0 standard units. Both results, according to 40 C.F.R 261.22, verify the characteristic of a hazardous waste for corrosivity (D002).

Photo 6: Sample Location MS-10 --- 55-gallon drum with a "Corrosive" label and was documented to have a pH of 13 standard units

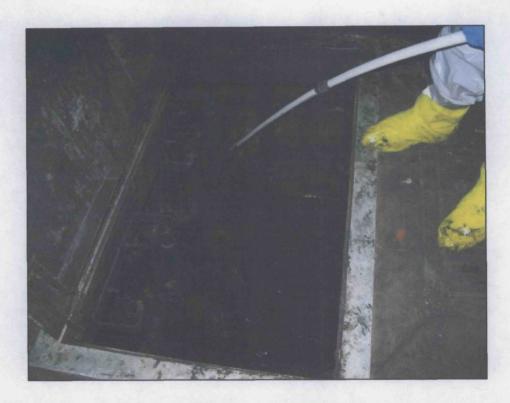
Photo 7: Wastewater treatment pit containing liquid and sludge (Ohio EPA sampled and documented TCLP PCE and ignitable hazardous waste

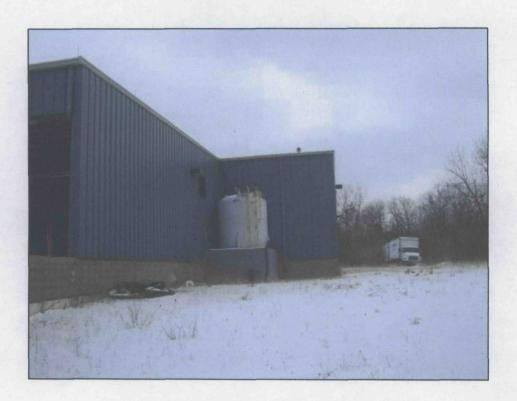
Additional inspections revealed Multi-Service was also exceeding the 90-day storage limit for hazardous waste stored in the 6,300-gallon tank located outside of the facility. The outside hazardous waste tank does not have proper secondary containment. Access is limited to the tank because of the design of the containment wall. Waste in the tank hardens in colder weather making removal difficult. The tank has not been cleaned out since 2008 (Ohio EPA, July 2009).

Photo 8: "Hazardous Waste" storage tank

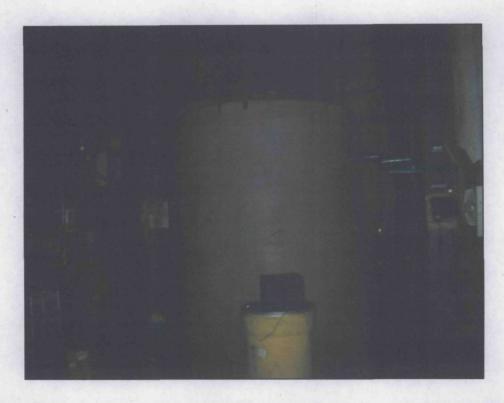
Drums and tanks were noted to be in a deteriorated condition with waste spilled on the floor in many locations, including adjacent to the floor drains. Analytical results from Chemical Mixing Tank sample MS-7 documented a TCLP PCE concentration of 53 mg/L. On April 22, 2010, Ohio EPA sampled the Chemical Mixing Tank and documented a TCLP PCE concentration of 30 mg/L. The analytical results from U.S. EPA and Ohio EPA's sampling indicate a TCLP PCE concentration greater than the TCLP PCE regulatory level of 0.7 mg/L, which, according to 40 C.F.R 261.24, verifies the characteristic of a hazardous waste for toxicity (D004). PCE is "hazardous Substance" as defined by Section 101(14) of CERCLA, 42 U.S.C. § 9601(14).

Photo 9: Sample Location MS-7 --- U.S. EPA documented the liquid in this Chemical Mixing Tank having TCLP PCE and ignitable hazardous waste

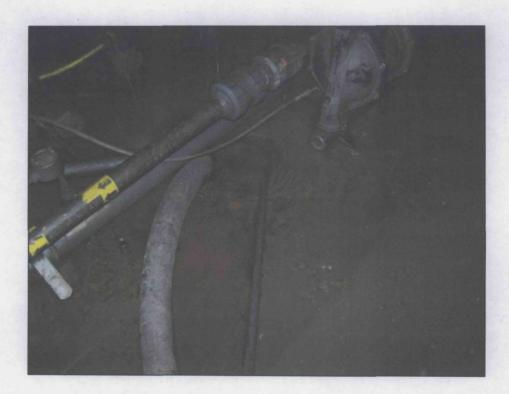
Photo 10: Overflowing pit containing a mixture of water and solvents in the Tank Room
